**Flood Control Project Maintenance  
Levee Inspections**  
**LMA District Cover Sheet**  
**Spring 2017 Levee Inspection Results**

**Levee District No. 0003 (Glenn County)**

**Levee Inspection Report By Mile - Spring 2017**

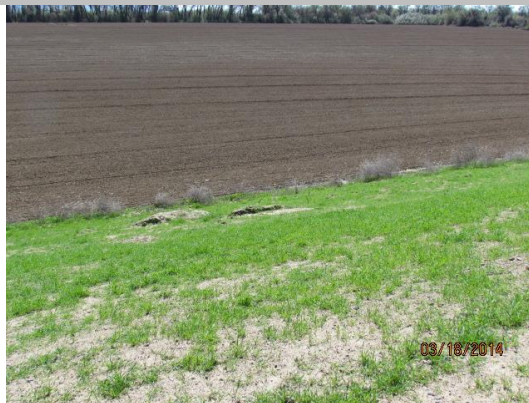
Photo 1 of 1 : SP\_2017\_LD0003\_27\_55\_20170315\_00030.jpg

View of the rodent activity along the waterside slope.

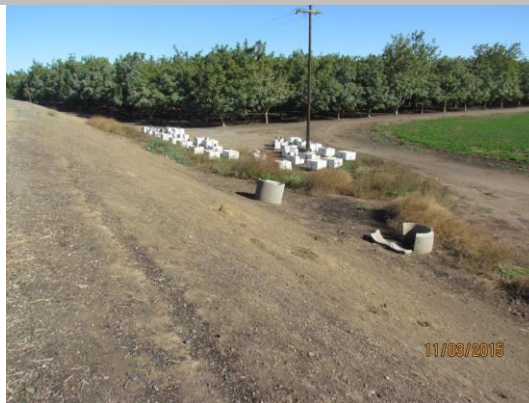
Photo 1 of 1 : SP\_2017\_LD0003\_27\_52\_20170315\_00029.jpg

View of the rodent holes along the landside slope.

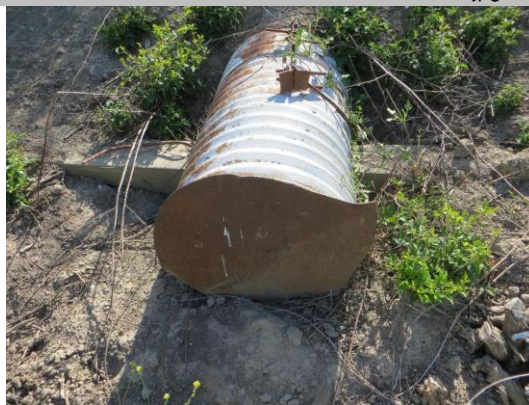
Photo 2 of 3 : UCIP\_SP\_2017\_14573\_24037.jpg

FS\_ID:14573  
DS\_ID:18830  
EP\_NO: 9930  
Repair Type: Non-Urgent  
Crossing Status: Found  
UCIP Comments: Steel plate welded over WS end of pipe. Slide gate at WS toe missing. Appears abandoned.  
FIELD\_STRUCT\_DESC: 24-inch corrugated metal pipe through the levee 14.5 feet below the crown slide gate on waterward end, 7'X9' concrete diversion box at landward toe (ABO No. 9930-Steel Ranch). Originally included in O+M manual (1960).  
FS Date: 6/4/2013

Steel plate welded over end of pipe on WS toe.

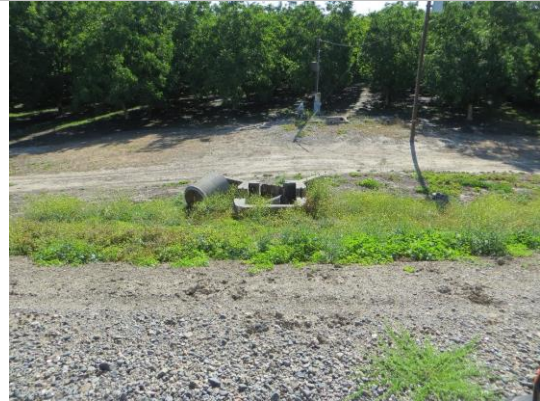
Photo 3 of 3 : UCIP\_SP\_2017\_14573\_24036.jpg

LM Start	1.47	Rating **	M	Issue No.	106 (cont)	
LM End	1.47	Issue Type +	En	Location *	WS	
Category	Supplemental			GPS Latitude/Longitude		
				Start	End	
Item	DWR UCIP Field Study			39.397780 °	39.397780 °	
				-122.002074 °	-122.002074 °	
DWR ID						
Comment Code						
Inspector Comment						
FS_ID:14573						
DS_ID:18830						
EP_NO: 9930						
Repair Type: Non-Urgent						
Crossing Status: Found						
UCIP Comments: Steel plate welded over WS end of pipe. Slide gate at WS toe missing. Appears abandoned.						
FIELD_STRUCT_DESC: 24-inch corrugated metal pipe through the levee 14.5 feet below the crown slide gate on waterward end, 7'X9' concrete diversion box at landward toe (ABO No. 9930-Steel Ranch). Originally included in O+M manual (1960).						
FS Date: 6/4/2013

Distribution box on LS toe.

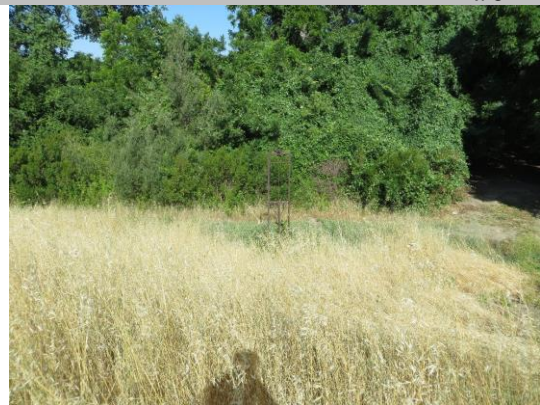
Photo 1 of 2 : UCIP\_SP\_2017\_14576\_24052.jpg

LM Start	1.58	Rating **	M	Issue No.	107
LM End	1.58	Issue Type +	En	Location *	WS
Category	Supplemental			GPS Latitude/Longitude	
				Start	End
Item	DWR UCIP Field Study			39.399330 °	39.399330 °
				-122.002402 °	-122.002402 °
DWR ID					
Comment Code					
Inspector Comment					
FS_ID:14576					
DS_ID:18823					
EP_NO: 9931					
Repair Type: Non-Urgent					
Crossing Status: Found					
UCIP Comments: Appears abandoned. Pipe burried at slide gate on WS toe.					
FIELD_STRUCT_DESC: 24-inch corrugated metal pipe through the levee 15.0 feet below the crown, slide gate on waterward end. 6'X7' concrete distribution box on LS toe. (ABO No. 9931-L. F. Steel).					
Originally included in the O+M manual (1960).					
FS Date: 6/4/2013

Slide gate at WS toe.

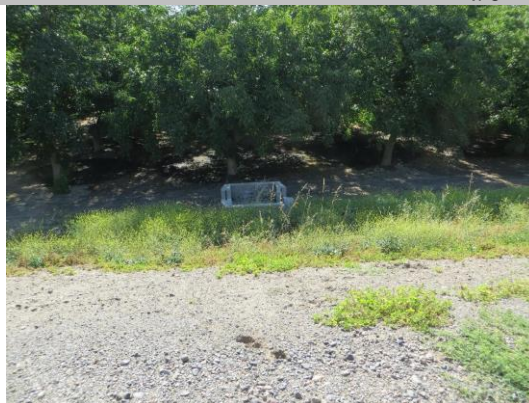
Photo 2 of 2 : UCIP\_SP\_2017\_14576\_24051.jpg

LM Start	1.58	Rating **	M	Issue No.	107 (cont)
LM End	1.58	Issue Type +	En	Location *	WS
Category	Supplemental			GPS Latitude/Longitude	
				Start	End
Item	DWR UCIP Field Study			39.399330 °	39.399330 °
				-122.002402 °	-122.002402 °
DWR ID					
Comment Code					
Inspector Comment					
FS_ID:14576					
DS_ID:18823					
EP_NO: 9931					
Repair Type: Non-Urgent					
Crossing Status: Found					
UCIP Comments: Appears abandoned. Pipe buried at slide gate on WS toe.					
FIELD_STRUCT_DESC: 24-inch corrugated metal pipe through the levee 15.0 feet below the crown, slide gate on waterward end. 6'X7' concrete distribution box on LS toe. (ABO No. 9931-L. F. Steel).					
Originally included in the O+M manual (1960).					
FS Date: 6/4/2013

Concrete distribution box at LS toe.

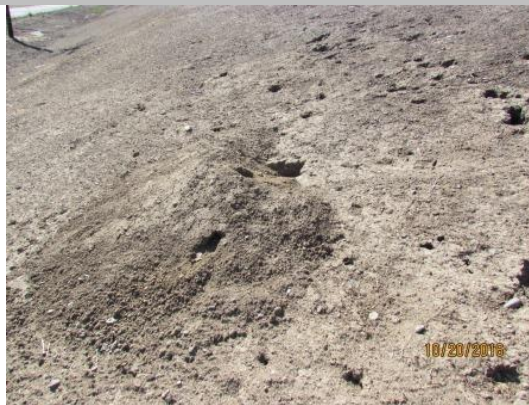
Photo 1 of 1 : SP\_2017\_LD0003\_27\_104\_20170315\_00058.jpg

LM Start	1.75	Rating **	U	Issue No.	104
LM End	1.98	Issue Type +	Ma	Location *	LS
Category	Earthen Levee			GPS Latitude/Longitude	
				Start	End
Item	Animal Control			39.401795 °	39.405018 °
				-122.002084 °	-122.001672 °
DWR ID	DWR_LD0003_01_f_2016_104				
Comment Code					
A1 : Exterminate rodents and backfill and compact or grout burrows.					
Inspector Comment

View of the rodent holes along the landside slope.

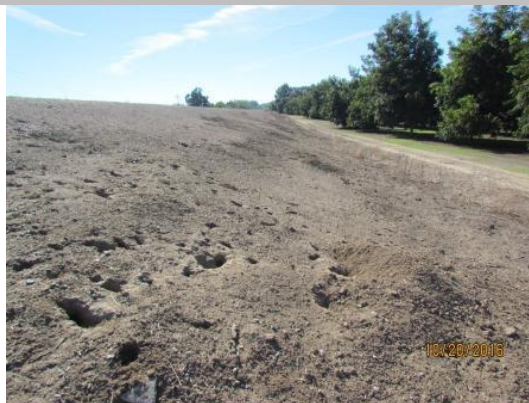
Photo 1 of 1 : SP\_2017\_LD0003\_27\_103\_20170315\_00057.jpg

View of the rodent holes along the waterside slope.

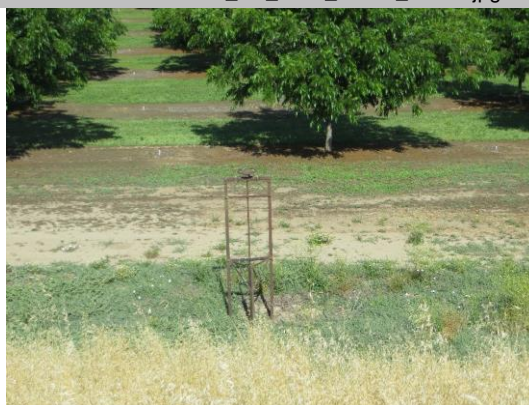
Photo 1 of 3 : UCIP\_SP\_2017\_14577\_24055.jpg

LM Start	1.87	Rating **	M	Issue No.	108
LM End	1.87	Issue Type +	En	Location *	WS
Category	Supplemental			GPS Latitude/Longitude	
				Start	End
Item	DWR UCIP Field Study			39.403419 °	39.403419 °
				-122.001871 °	-122.001871 °
DWR ID					
Comment Code					
Inspector Comment					
FS_ID:14577					
DS_ID:18825					
EP_NO: 9935					
Repair Type: Non-Urgent					
Crossing Status: Found					
UCIP Comments: Appears abandoned. Pipe buried on WS toe.					
Debris and steel plate blocking inlet on LS.					
FIELD_STRUCT_DESC: 24-inch corrugated metal pipe through the					
levee and beneath the roadway 18.0 feet below the crown, slide gate on					
waterward end (ABO No. 9935-Watt). Originally included in the O+M					
manual (1960).					
FS Date: 6/4/2013

Slide gate buried at WS toe.

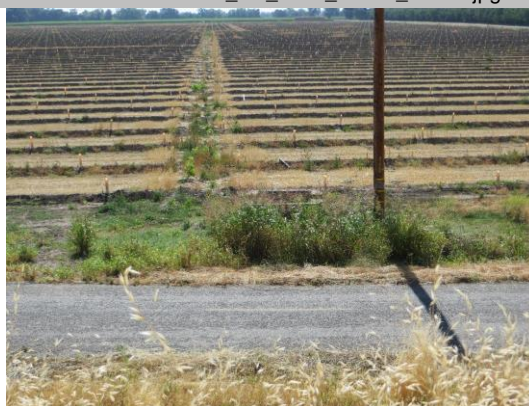
Photo 2 of 3 : UCIP\_SP\_2017\_14577\_24054.jpg

LM Start	1.87	Rating **	M	Issue No.	108 (cont)	
LM End	1.87	Issue Type +	En	Location *	WS	
Category	Supplemental			GPS Latitude/Longitude		
				Start		End
Item	DWR UCIP Field Study			39.403419 °		39.403419 °
				-122.001871 °		-122.001871 °
DWR ID						
Comment Code						
Inspector Comment						
FS_ID:14577						
DS_ID:18825						
EP_NO: 9935						
Repair Type: Non-Urgent						
Crossing Status: Found						
UCIP Comments: Appears abandoned. Pipe buried on WS toe.						
Debris and steel plate blocking inlet on LS.						
FIELD_STRUCT_DESC: 24-inch corrugated metal pipe through the						
levee and beneath the roadway 18.0 feet below the crown, slide gate on						
waterward end (ABO No. 9935-Watt). Originally included in the O+M						
manual (1960).						
FS Date: 6/4/2013

Concrete distribution box off LS toe.

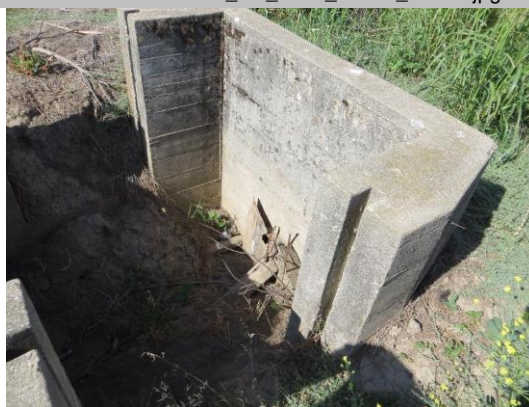
Photo 3 of 3 : UCIP\_SP\_2017\_14577\_24053.jpg

Debris and steel plate blocking inlet on LS toe.

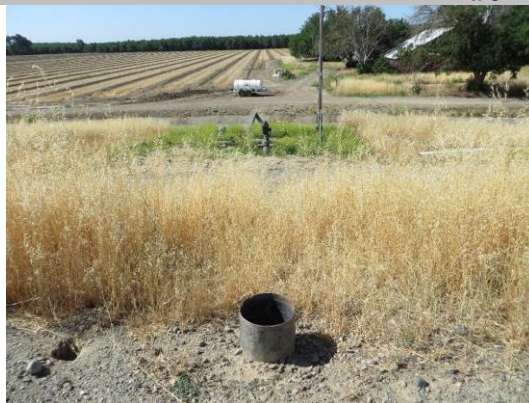
Photo 1 of 3 : UCIP\_SP\_2017\_15144\_24883.jpg

LM Start	2.10	Rating **	M	Issue No.	109
LM End	2.10	Issue Type +	En	Location *	WS
Category	Supplemental			GPS Latitude/Longitude	
				Start	End
Item	DWR UCIP Field Study			39.406353 °	39.406353 °
				-122.000674 °	-122.000674 °
DWR ID					
Comment Code					
Inspector Comment					
FS_ID:15144					
DS_ID:23151					
EP_NO: N/A					
Repair Type: Non-Urgent					
Crossing Status: Found					
UCIP Comments: No permit identified for this crossing.					
FIELD_STRUCT_DESC: 12-inch steel irrigation pipe through the levee					
3.5-feet below the crown. Pump, butterfly valve, JP/meter at channel					
on LS toe. Siphon breaker in 12-inch steel riser on LS shoulder. 3-inch					
plastic drain on WS toe.					
FS Date: 6/4/2013

Siphon breaker in steel riser on LS shoulder with pump in background.

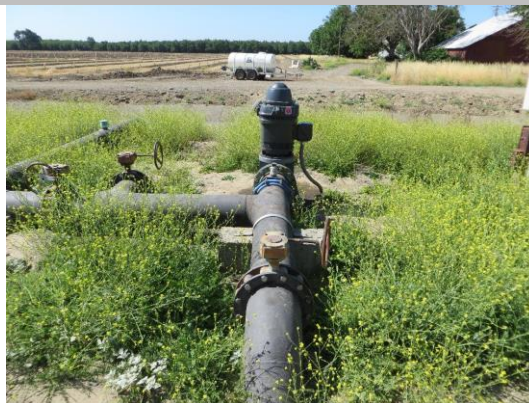
Photo 2 of 3 : UCIP\_SP\_2017\_15144\_24882.jpg

Pump and butterfly valve off LS toe.

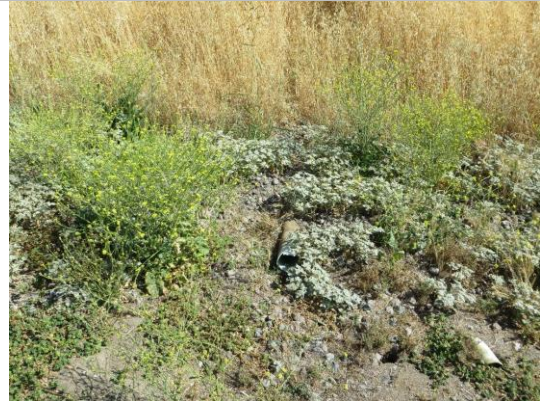
Photo 3 of 3 : UCIP\_SP\_2017\_15144\_24881.jpg

LM Start	2.10	Rating **	M	Issue No.	109 (cont)
LM End	2.10	Issue Type +	En	Location *	WS
Category	Supplemental			GPS Latitude/Longitude	
				Start	End
Item	DWR UCIP Field Study			39.406353 °	39.406353 °
				-122.000674 °	-122.000674 °
DWR ID					
Comment Code					
Inspector Comment					
FS_ID:15144 DS_ID:23151 EP_NO: N/A Repair Type: Non-Urgent Crossing Status: Found UCIP Comments: No permit identified for this crossing. FIELD_STRUCT_DESC: 12-inch steel irrigation pipe through the levee 3.5-feet below the crown. Pump, butterfly valve, JP/meter at channel on LS toe. Siphon breaker in 12-inch steel riser on LS shoulder. 3-inch plastic drain on WS toe. FS Date: 6/4/2013

3-inch drain on WS toe (purpose unclear).

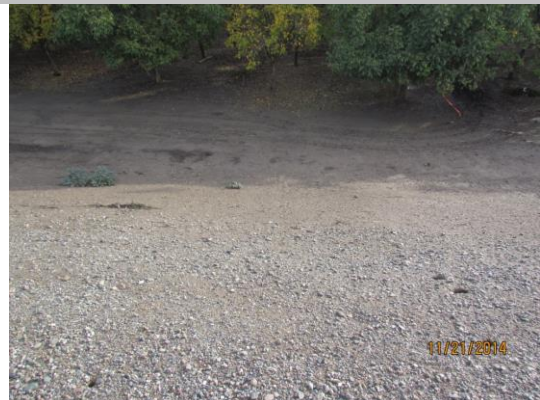
Photo 1 of 1 : SP\_2017\_LD0003\_27\_13\_20170315\_00011.jpg

LM Start	2.35	Rating **	M	Issue No.	13
LM End	2.52	Issue Type +	Ma	Location *	WS
Category	Earthen Levee			GPS Latitude/Longitude	
				Start	End
Item	Animal Control			39.406413 °	39.407248 °
				-121.995993 °	-121.993177 °
DWR ID	DWR_LD0003_01_s_2012_13				
Comment Code					
A3 : No rodents visible, but rodent burrows visible; need to backfill and compact or grout burrows.					
Inspector Comment

View of the rodent holes along the waterside slope.

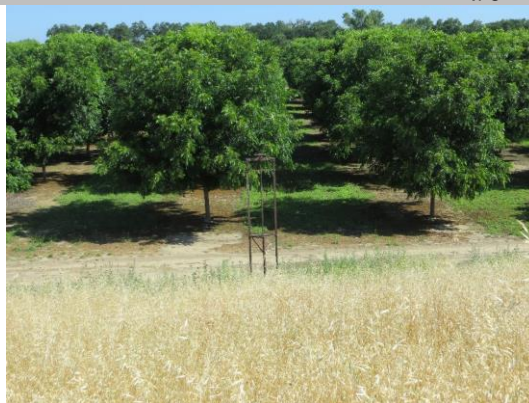
Photo 1 of 3 : UCIP\_SP\_2017\_14582\_24076.jpg

LM Start	2.38	Rating **	M	Issue No.	110
LM End	2.38	Issue Type +	En	Location *	WS
Category	Supplemental			GPS Latitude/Longitude	
				Start	End
Item	DWR UCIP Field Study			39.406471 °	39.406471 °
				-121.995551 °	-121.995551 °
DWR ID					
Comment Code					
Inspector Comment					
FS_ID:14582					
DS_ID:18827					
EP_NO: 9936					
Repair Type: Non-Urgent					
Crossing Status: Found					
UCIP Comments: Appears abandoned. Pipe buried on WS and blocked with tin and soil on the LS.					
FIELD_STRUCT_DESC: 24-inch corrugated metal pipe through the levee 18.3 feet below crown, slide gate on waterward end. 5-foot by 7-foot concrete distribution box at landward toe (ABO No. 9936-Watt). Originally included in the O+M manual (1960).					
FS Date: 6/4/2013

Slide gate at WS toe.

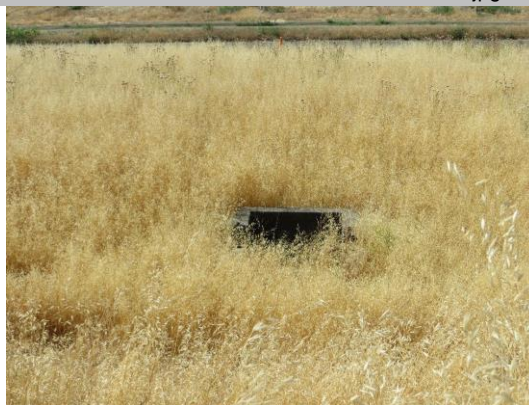
Photo 2 of 3 : UCIP\_SP\_2017\_14582\_24075.jpg

Concrete distribution box on LS toe.

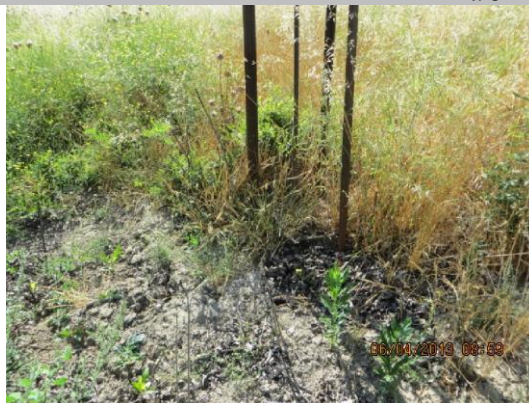
Photo 3 of 3 : UCIP\_SP\_2017\_14582\_24074.jpg

LM Start	2.38	Rating **	M	Issue No.	110 (cont)
LM End	2.38	Issue Type +	En	Location *	WS
Category	Supplemental			GPS Latitude/Longitude	
				Start	End
Item	DWR UCIP Field Study			39.406471 °	39.406471 °
				-121.995551 °	-121.995551 °
DWR ID					
Comment Code					
Inspector Comment					
FS_ID:14582					
DS_ID:18827					
EP_NO: 9936					
Repair Type: Non-Urgent					
Crossing Status: Found					
UCIP Comments: Appears abandoned. Pipe buried on WS and blocked with tin and soil on the LS.					
FIELD_STRUCT_DESC: 24-inch corrugated metal pipe through the levee 18.3 feet below crown, slide gate on waterward end. 5-foot by 7-foot concrete distribution box at landward toe (ABO No. 9936-Watt). Originally included in the O+M manual (1960).					
FS Date: 6/4/2013

Slide gate at WS toe.

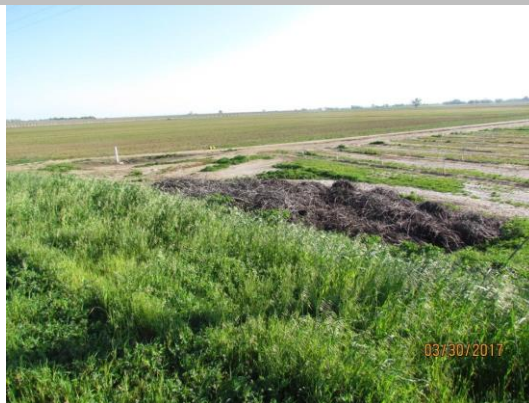
Photo 1 of 1 : SP\_2017\_LD0003\_27\_43\_20170330\_00100.jpg

View of the prunings along the landside toe.

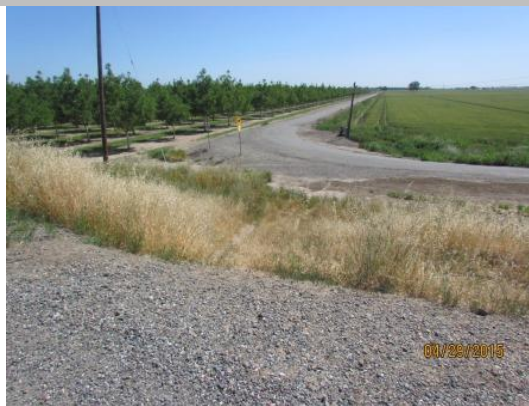
Photo 1 of 1 : SP\_2017\_LD0003\_27\_9\_20170315\_00006.jpg

LM Start	3.39	Rating **	M	Issue No.	9
LM End	3.39	Issue Type +	Ma	Location *	LS
Category	Earthen Levee			GPS Latitude/Longitude	
				Start	End
Item	Slope Stability			39.418382 °	39.418382 °
				-121.992480 °	-121.992480 °
DWR ID	DWR_LD0003_01_s_2012_9				
Comment Code					
S3 : Repair the levee slope damaged by vehicle traffic and prevent access where possible.					
Inspector Comment					
Repair the erosion along the landside slope and prevent vehicle access

View of the vehicle erosion along the landside slope.

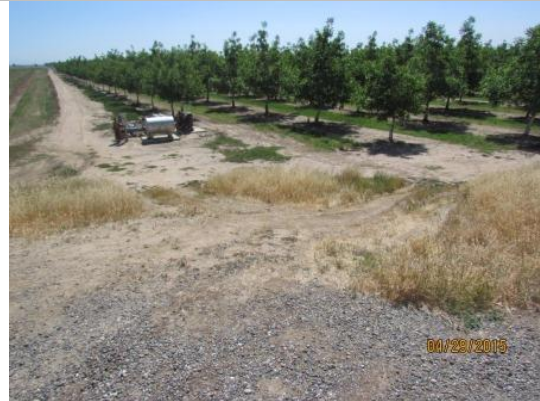
Photo 1 of 1 : SP\_2017\_LD0003\_27\_19\_20170315\_00013.jpg

LM Start	3.76	Rating **	M	Issue No.	19
LM End	3.76	Issue Type +	Ma	Location *	LS
Category	Earthen Levee			GPS Latitude/Longitude	
				Start	End
Item	Slope Stability			39.423747 °	39.423747 °
				-121.991667 °	-121.991667 °
DWR ID	DWR_LD0003_01_s_2012_19				
Comment Code					
S3 : Repair the levee slope damaged by vehicle traffic and prevent access where possible.					
Inspector Comment

View of the vehicle erosion along the landside slope.

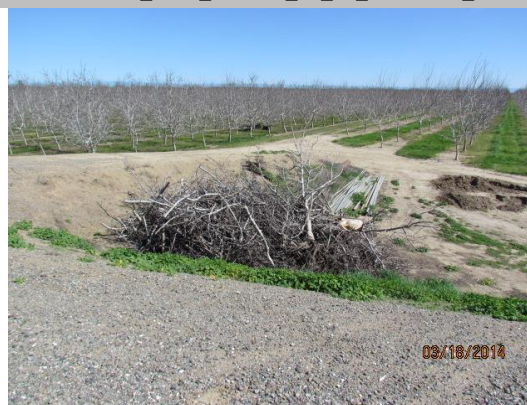
Photo 1 of 1 : SP\_2017\_LD0003\_27\_68\_20170315\_00039.jpg

View of the prunings along the landside toe.

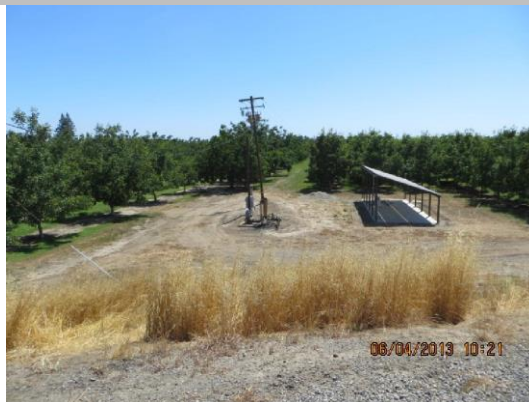
Photo 2 of 3 : UCIP\_SP\_2017\_15163\_24901.jpg

Pumping plant off LS toe.

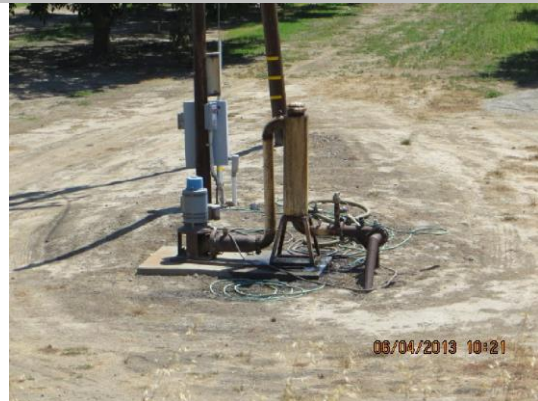
Photo 3 of 3 : UCIP\_SP\_2017\_15163\_24900.jpg

LM Start	4.96	Rating **	M	Issue No.	112 (cont)
LM End	4.96	Issue Type +	En	Location *	LS
Category	Supplemental			GPS Latitude/Longitude	
				Start	End
Item	DWR UCIP Field Study			39.439791 °	39.439791 °
				-121.989825 °	-121.989825 °
DWR ID					
Comment Code					
Inspector Comment					
FS_ID:15163 DS_ID:23152 EP_NO: N/A Repair Type: Non-Urgent Crossing Status: Found UCIP Comments: No permit identified for this crossing. FIELD_STRUCT_DESC: 4-inch steel irrigation pipe through the levee at an unknown depth. Pump, vent, and shutoff valve off LS toe. Possible shutoff valve off WS toe. FS Date: 6/4/2013

Pumping plant off LS toe.

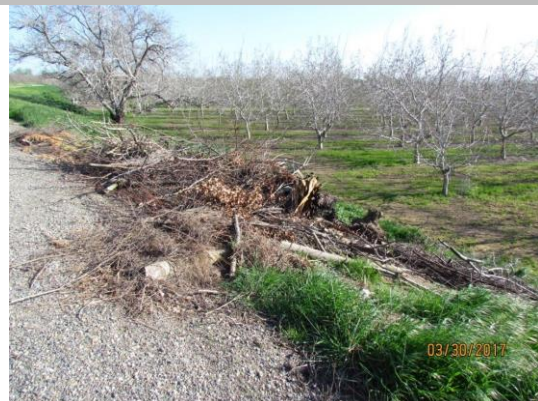
Photo 1 of 1 : SP\_2017\_LD0003\_27\_44\_20170330\_00101.jpg

View of the prunings along the landside slope and toe.

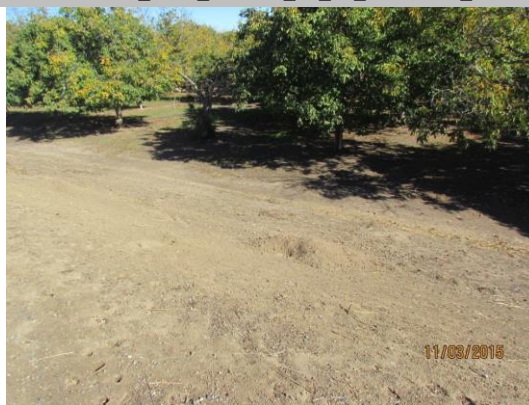
Photo 1 of 1 : SP\_2017\_LD0003\_27\_70\_20170315\_00041.jpg

View of the rodent holes along the landside slope.

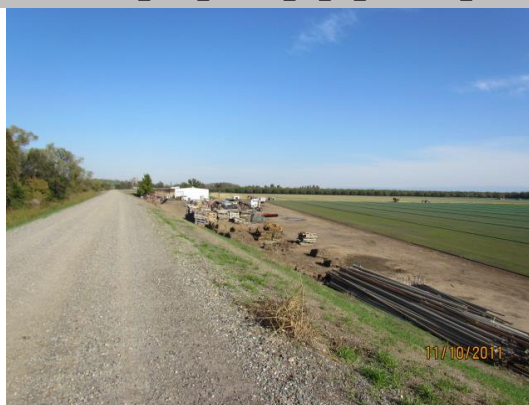
Photo 1 of 1 : SP\_2017\_LD0003\_27\_25\_20170315\_00015.jpg

View of the equipment along the landside toe.

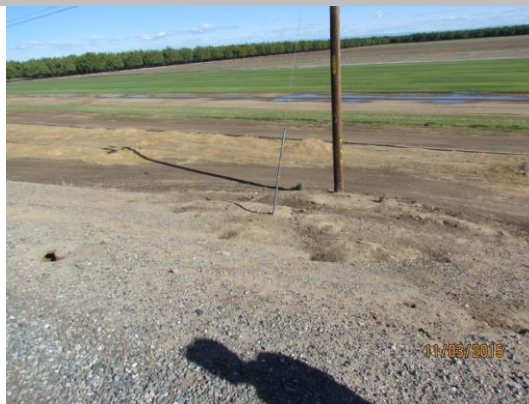
Photo 1 of 1 : SP\_2017\_LD0003\_27\_71\_20170315\_00042.jpg

View of the rodent holes along the landside slope.

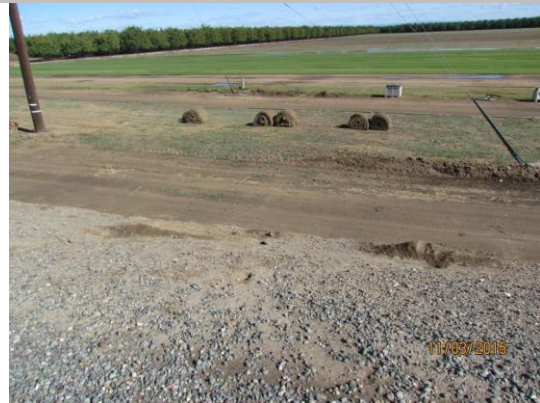
Photo 1 of 1 : SP\_2017\_LD0003\_27\_72\_20170315\_00043.jpg

View of the rodent holes along the landside slope.

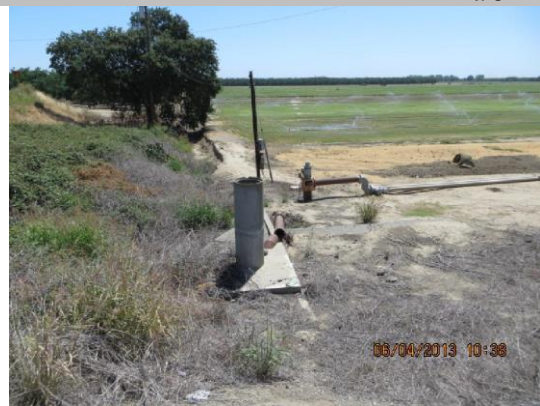
Photo 1 of 3 : UCIP\_SP\_2017\_14643\_24142.jpg

Concrete standpipe on LS toe.

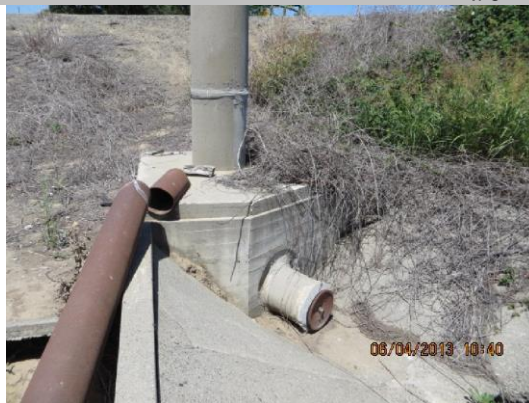
Photo 2 of 3 : UCIP\_SP\_2017\_14643\_24141.jpg

Concrete standpipe and channel on LS toe.

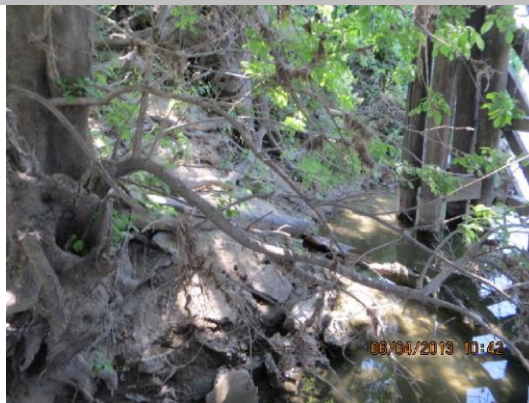
Photo 3 of 3 : UCIP\_SP\_2017\_14643\_24140.jpg

14-inch Pipe debris on WS toe.

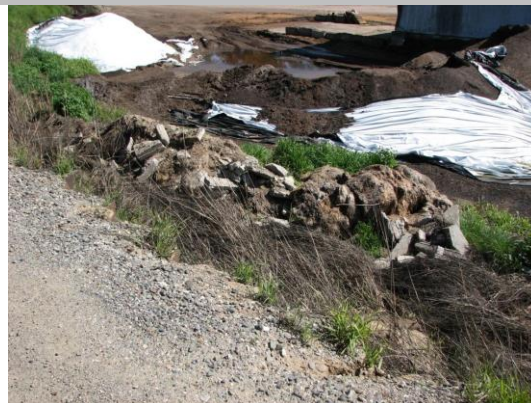
Photo 1 of 1 : SP\_2017\_LD0003\_27\_65\_20170315\_00037.jpg

View of concrete and soil obstructing visibility and access.

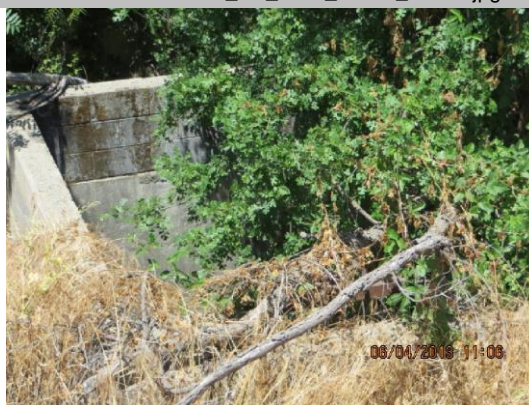
Photo 2 of 3 : UCIP\_SP\_2017\_14664\_24161.jpg

7'X12' Concrete box with flap gate and slide gate on WS slope.

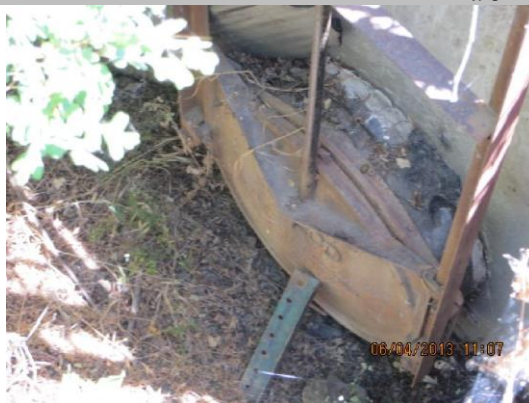
Photo 3 of 3 : UCIP\_SP\_2017\_14664\_24160.jpg

Slidegate inside concrete box on WS slope.

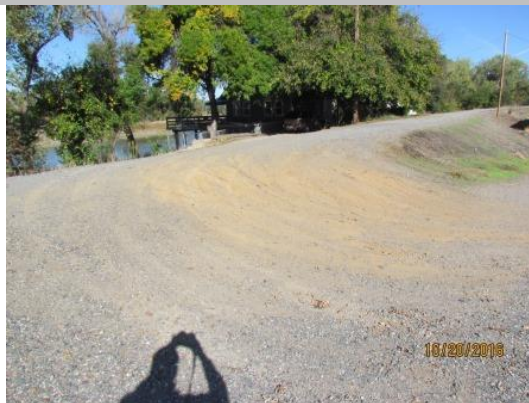
Photo 1 of 1 : SP\_2017\_LD0003\_27\_34\_20170315\_00018.jpg

View of slope instability caused by vehicle traffic.

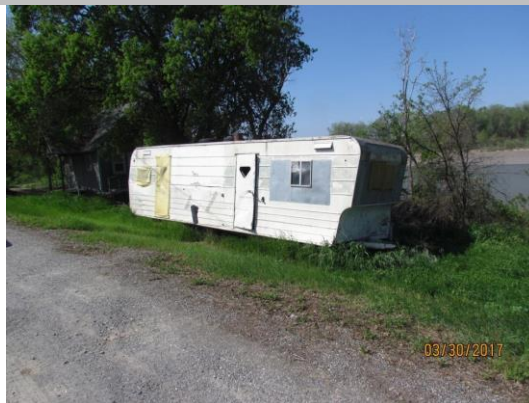
Photo 1 of 1 : SP\_2017\_LD0003\_27\_54\_20170330\_00103.jpg

View the trailer on the waterside slope.

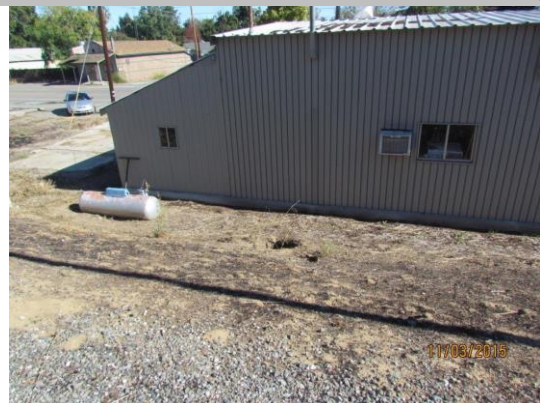
Photo 1 of 1 : SP\_2017\_LD0003\_27\_76\_20170315\_00045.jpg

View of the burned out stump hole along the landside toe.

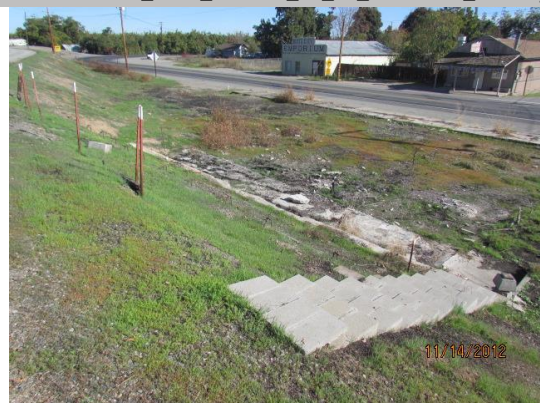
Photo 1 of 1 : SP\_2017\_LD0003\_27\_12\_20170315\_00010.jpg

View of concrete stairs &amp; foundation along the slope of the levee.

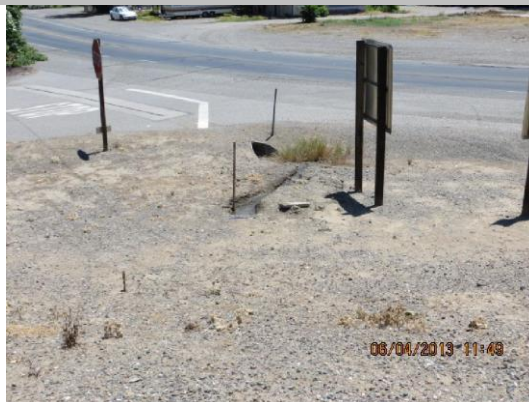
Photo 2 of 3 : UCIP\_SP\_2017\_15165\_24905.jpg

Pipe leaking at LS toe.

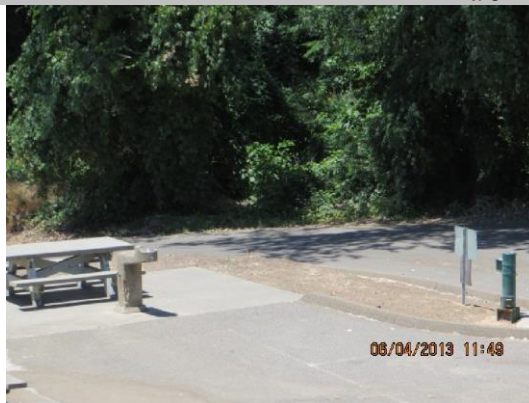
Photo 3 of 3 : UCIP\_SP\_2017\_15165\_24904.jpg

Possible reason for water service (water fountain).

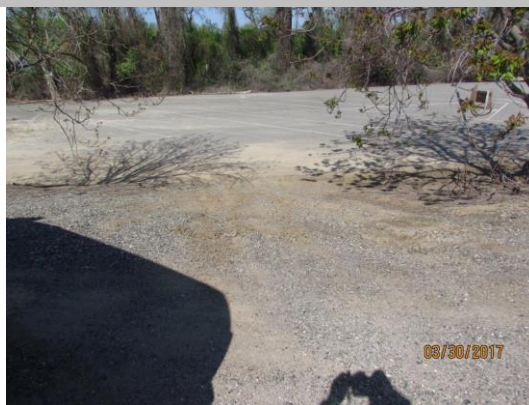
Photo 1 of 1 : SP\_2017\_LD0003\_27\_97\_20170330\_00102.jpg

View of the vehicle ruts on the waterside slope.

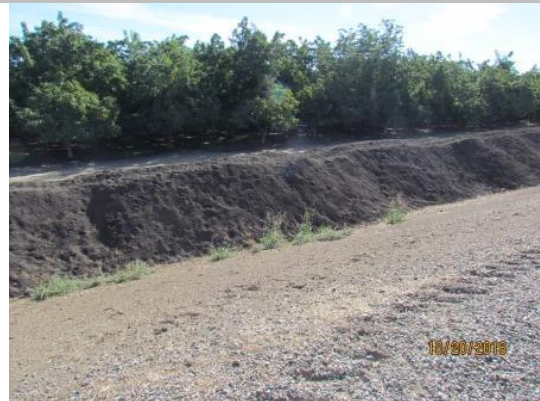
Photo 1 of 1 : SP\_2017\_LD0003\_27\_96\_20170315\_00054.jpg

View of a large pile of mulch along the landside toe.

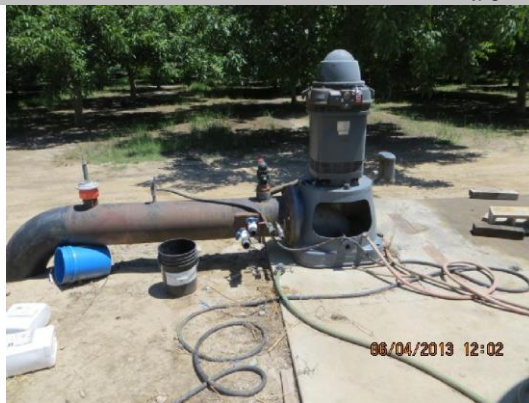
Photo 1 of 2 : UCIP\_SP\_2017\_14686\_24184.jpg

Pump located on LS toe next to concrete distribution box.

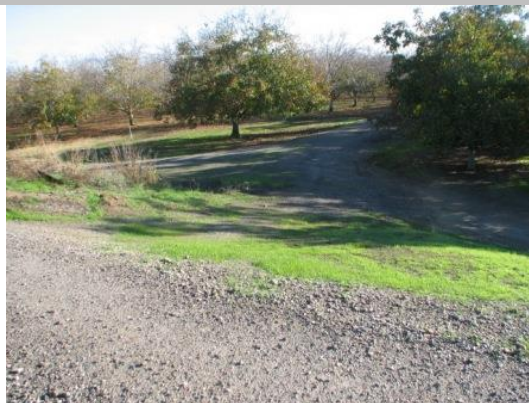
Photo 1 of 1 : SP\_2017\_LD0003\_27\_14\_20170315\_00012.jpg

View of the vehicle erosion along the landside slope.

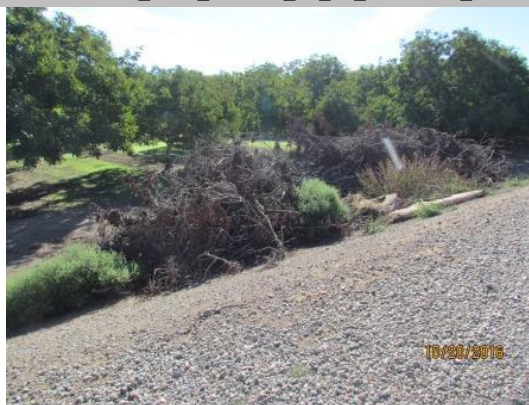
Photo 1 of 1 : SP\_2017\_LD0003\_27\_61\_20170315\_00033.jpg

View of the pruning along the landside toe.

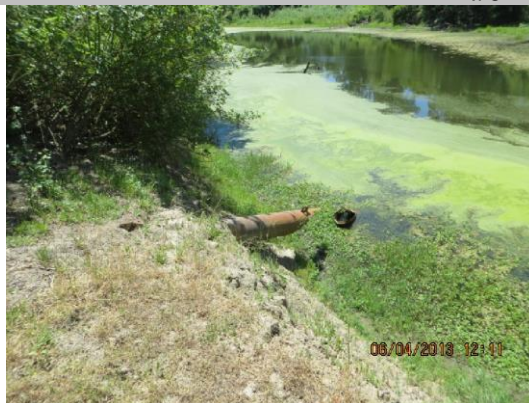
Photo 1 of 3 : UCIP\_SP\_2017\_14687\_24187.jpg

Pipe visible at pond off WS toe.

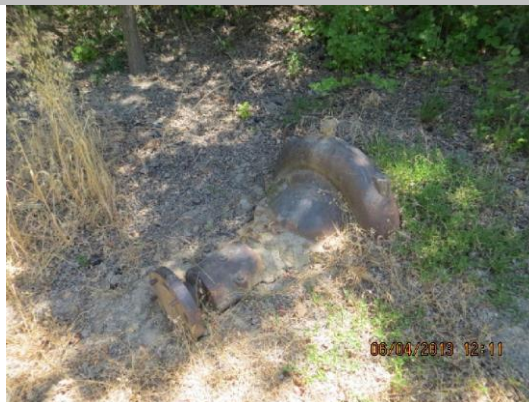
Photo 2 of 3 : UCIP\_SP\_2017\_14687\_24186.jpg

Pump visible off WS toe, next to pond.

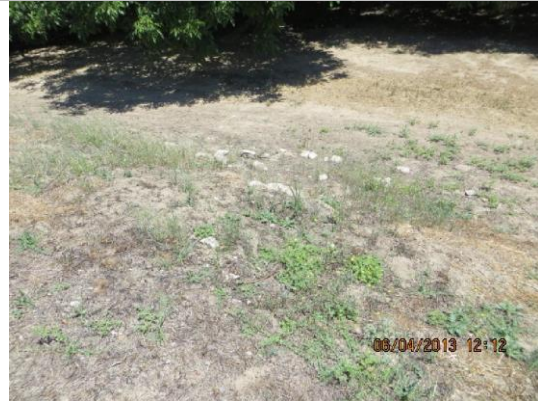
Photo 3 of 3 : UCIP\_SP\_2017\_14687\_24185.jpg

Remnants of concrete distribution box on LS toe.

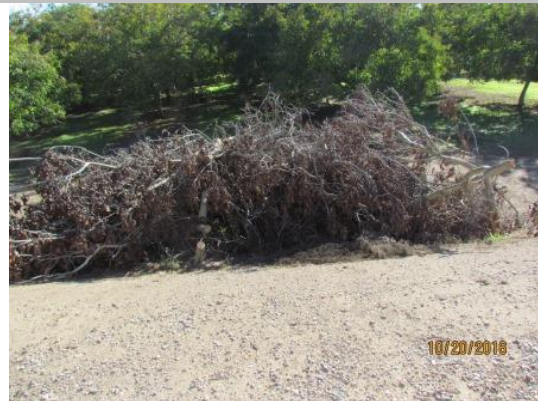
Photo 1 of 1 : SP\_2017\_LD0003\_27\_60\_20170315\_00032.jpg

View of the prunings along the landside toe.

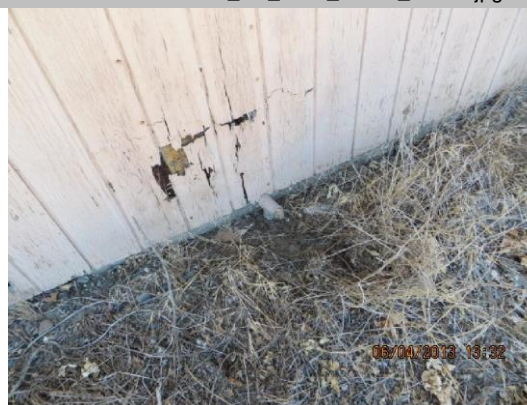
Photo 1 of 3 : UCIP\_SP\_2017\_14688\_24190.jpg

Pipe at side of building on WS shoulder.

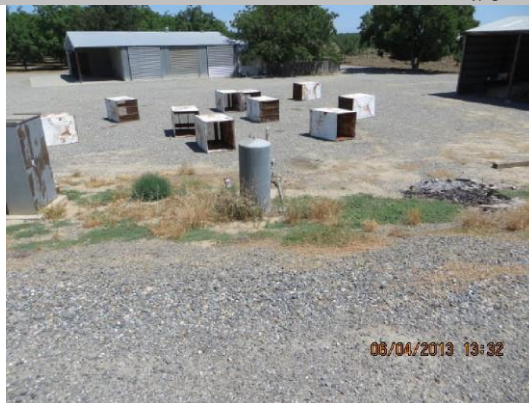
Photo 2 of 3 : UCIP\_SP\_2017\_14688\_24189.jpg

Water tank, pump, and well head on LS toe.

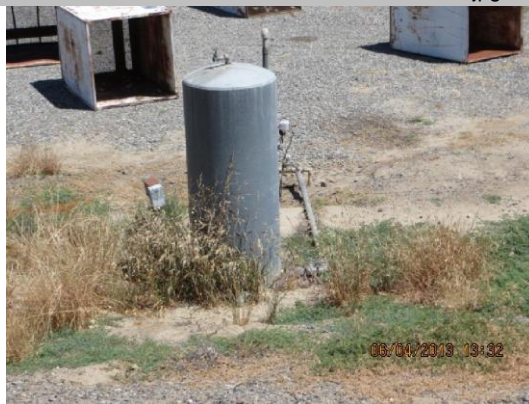
Photo 3 of 3 : UCIP\_SP\_2017\_14688\_24188.jpg

Water tank, pump, and well head on LS toe.

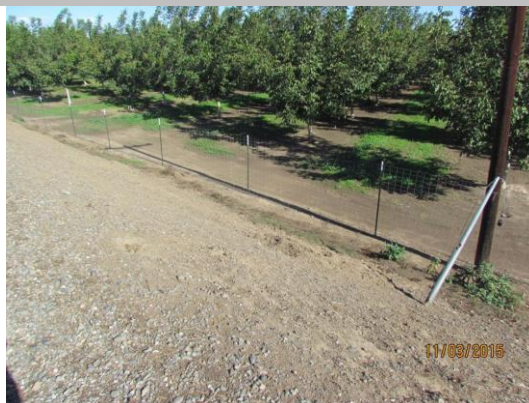
Photo 1 of 1 : SP\_2017\_LD0003\_27\_79\_20170315\_00048.jpg

View of the rodent holes along the landside slope.

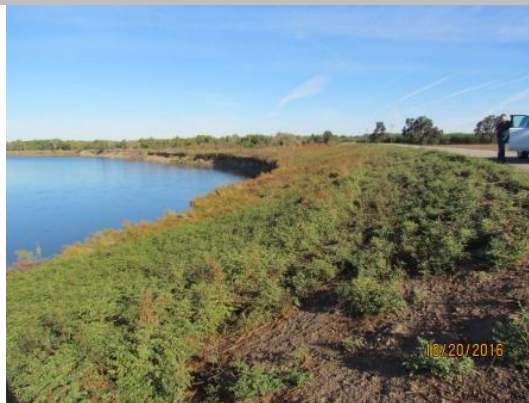
Photo 1 of 6 : SP\_2017\_LD0003\_27\_50\_20170315\_00023.jpg

View of the erosion along the waterside toe. Same site as the USACE erosion issue. Photo: 10/20/2016

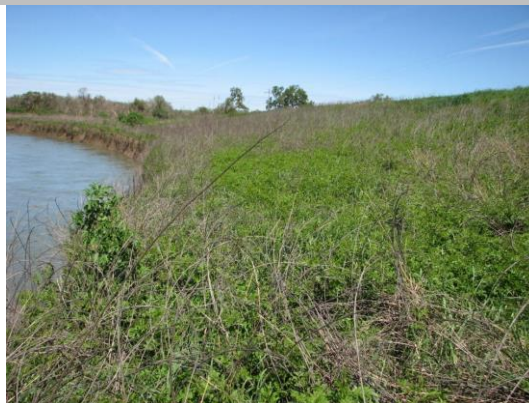
Photo 3 of 6 : SP\_2017\_LD0003\_27\_50\_20170315\_00025.jpg

View of erosion along the waterside toe. Same site as the USACE erosion issue. Photo 3/25/2016

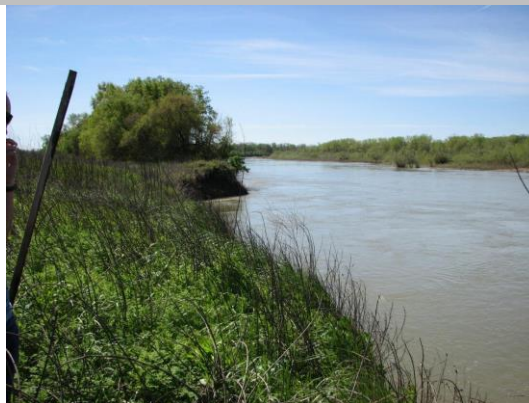
Photo 4 of 6 : SP\_2017\_LD0003\_27\_50\_20170315\_00026.jpg

View of erosion along the waterside toe, downstream. Same site as the USACE erosion issue. Photo 3/25/2016

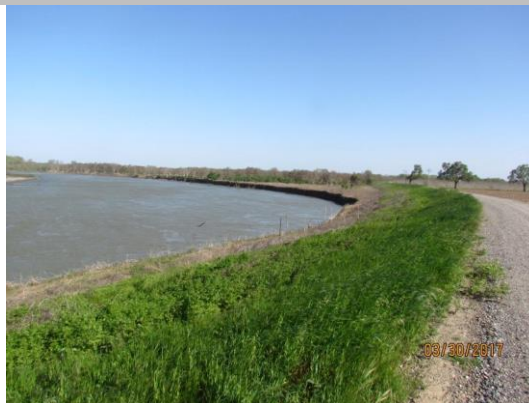
Photo 6 of 6 : SP\_2017\_LD0003\_27\_50\_20170330\_00106.jpg

View of the erosion along the waterside toe. Same site as the USACE erosion issue.

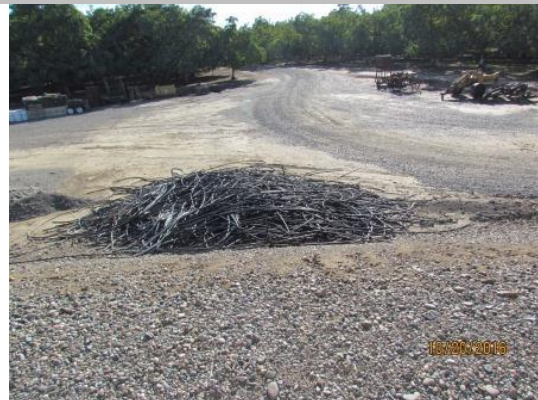
Photo 1 of 1 : SP\_2017\_LD0003\_27\_91\_20170315\_00050.jpg

View of the polyethylene pipes along the landside toe.

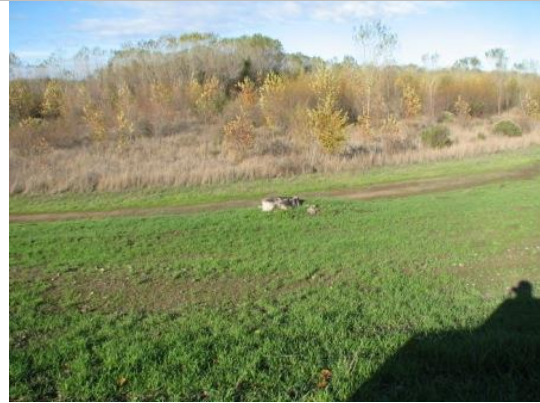
Photo 1 of 1 : SP\_2017\_LD0003\_27\_29\_20170315\_00016.jpg

View of the stump along the toe.

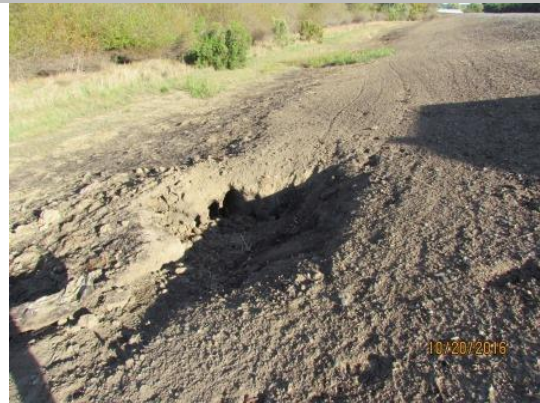
Photo 1 of 1 : SP\_2017\_LD0003\_27\_89\_20170315\_00049.jpg

View of a hole along the waterside slope that need to be backfilled and compacted.

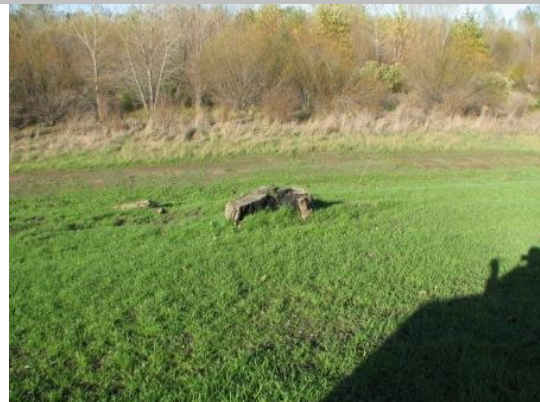
Photo 1 of 1 : SP\_2017\_LD0003\_27\_30\_20170315\_00017.jpg

View of the stump along the slope.

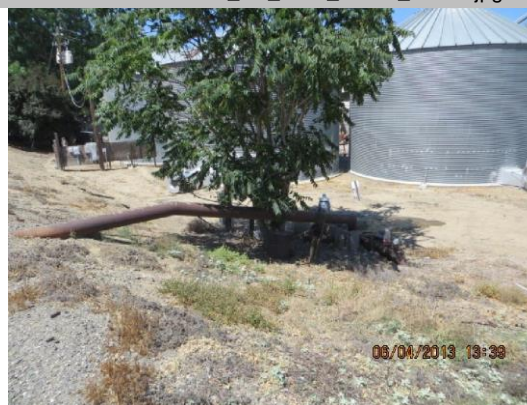
Photo 1 of 3 : UCIP\_SP\_2017\_14690\_24193.jpg

10-inch pipe and pump on LS.

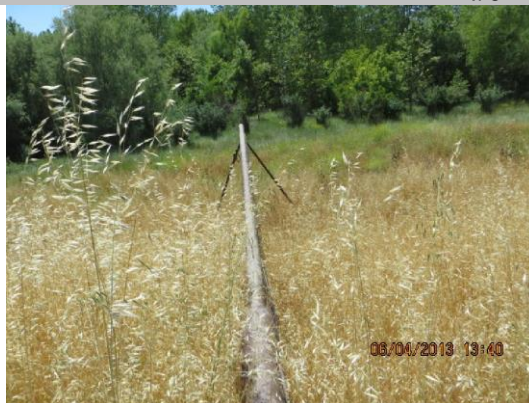
Photo 2 of 3 : UCIP\_SP\_2017\_14690\_24192.jpg

Pipe on WS shoulder.

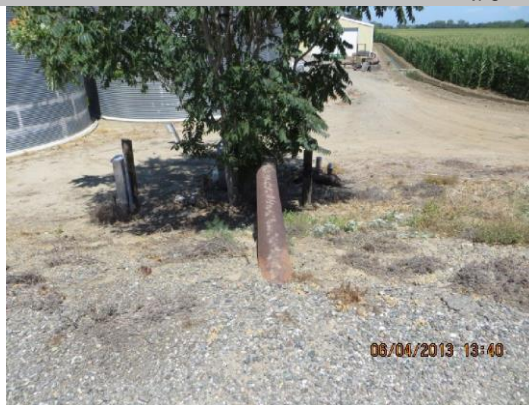
Photo 3 of 3 : UCIP\_SP\_2017\_14690\_24191.jpg

10-inch pipe on LS.

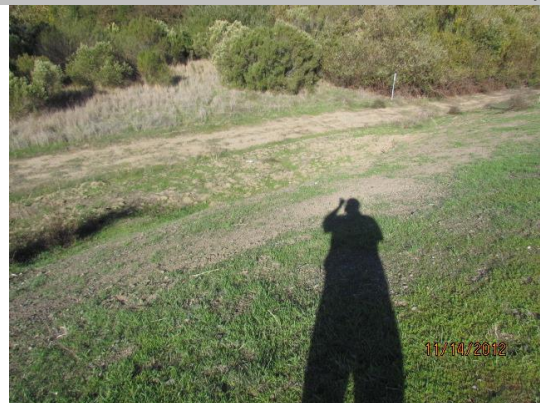
Photo 1 of 1 : SP\_2017\_LD0003\_27\_6\_20170315\_00004.jpg

View of the vertical cut along the waterside toe.
